Inspection Report

32215 ***** Dr
Abbotsford, BC V2T 5C7

West Coast Home Inspections Ltd.

Date: 2/19/2007	Time: 10:30 AM	Report ID: 070219
Property: 32215 ***** Dr Abbotsford, BC V2T 5C7	Customer: P ***** M *****	Real Estate Professional: Colleen Love Landmark

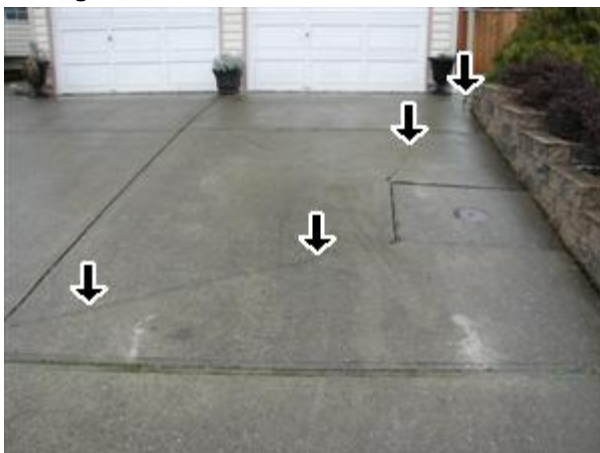
1.0 Picture 1

1.0 Some settling cracks noted in driveway. Cosmetic in nature but I recommend the homeowner seal any cracks to prevent water intrusion, which can lead to more extensive damage.

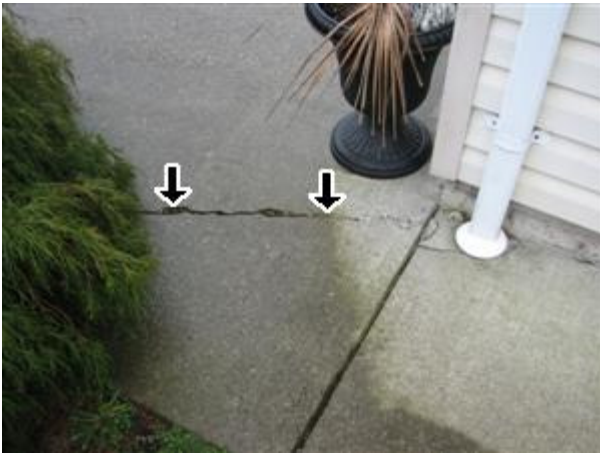
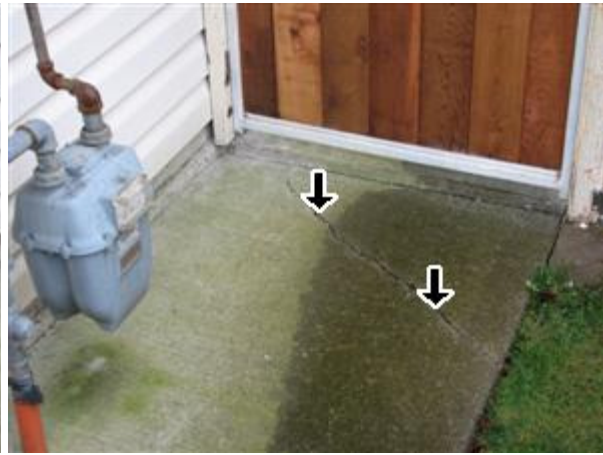
1.1 Some minor settling over the years in the concrete sidewalk. Cosmetic in nature. Recommend a high quality, flexible caulking be placed between the sidewalk and the wall to minimize chances of water penetration at the foundation.

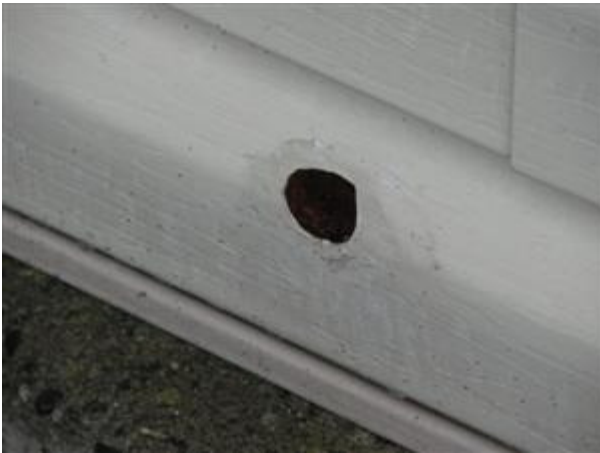
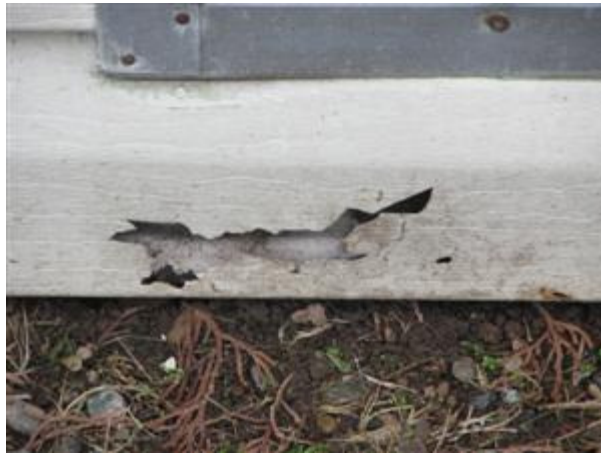
As with all vinyl siding, it expands and contracts with the warm & cold seasons. Therefore it is recommended that wherever a penetration occurs (downspouts, electrical masts, etc.), that the hole in the siding be "slotted" to allow for movement, with caulking applied to prevent water penetration.

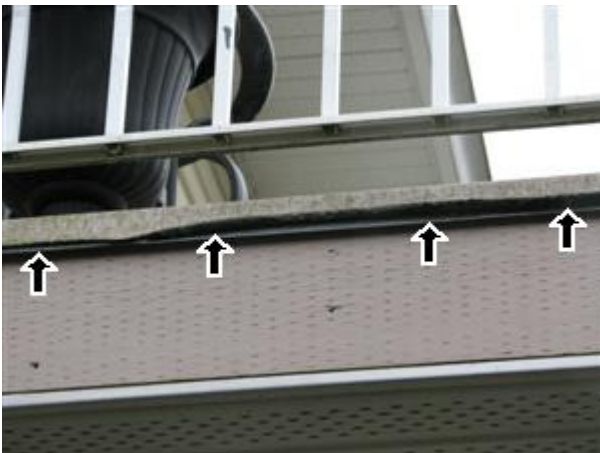
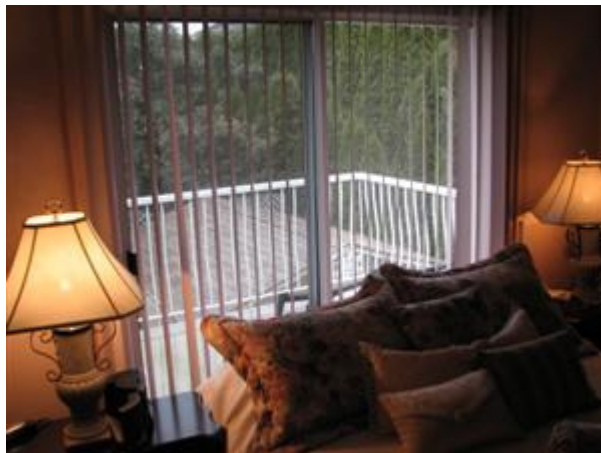
I was not able to "walk" the deck to confirm the condition of the substrate due to the exit door being blocked by a bed.

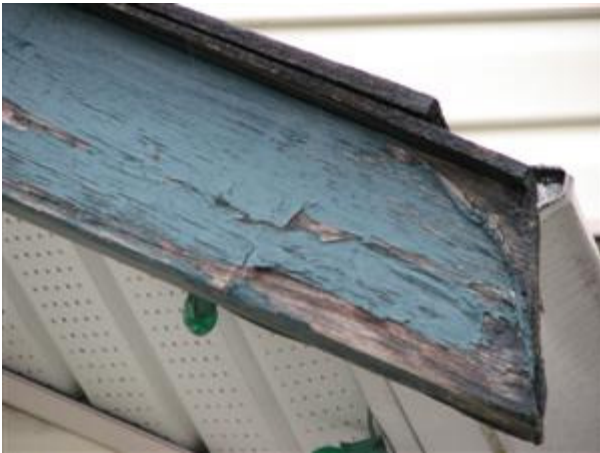
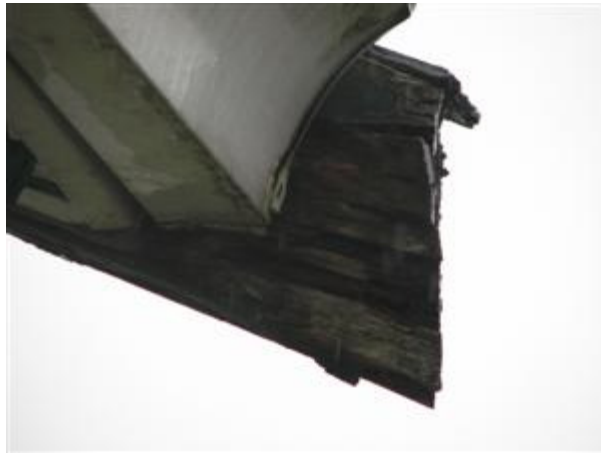
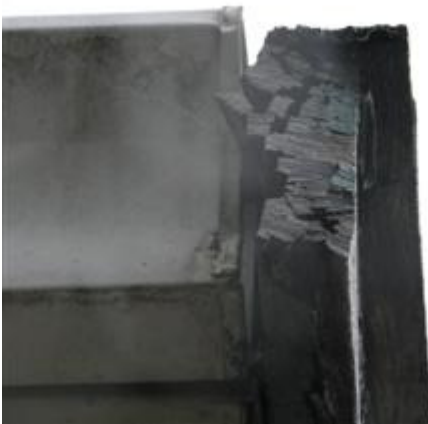
While the soffits and eaves are in good condition, the fascia at the front of the home has deteriorated due to exposure to extreme weather conditions and requires replacing. I recommend a licenced contractor perform replace the rotted and damaged fascia board with new and painted board.

2.5 While the soffits and eaves are in good condition, the fascia at the front of the home has deteriorated due to exposure to extreme weather conditions and requires replacing. I recommend a licenced contractor perform replace the rotted and damaged fascia board with new and painted board.

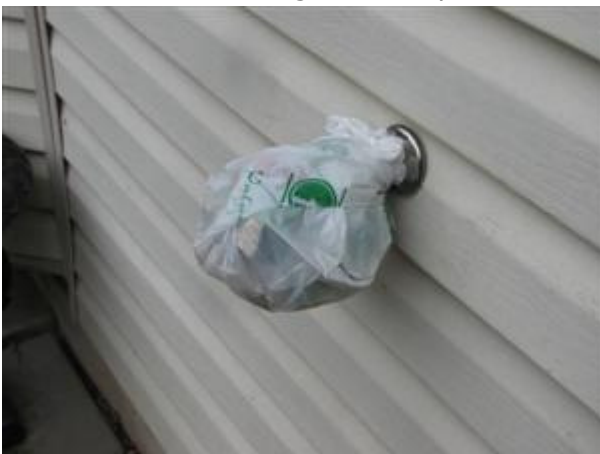
2.6 Picture 1

2.6 The exterior hose bibs have been winterized and checking them was not possible. I recommend conversing with the present homeowner as to their operational condition.

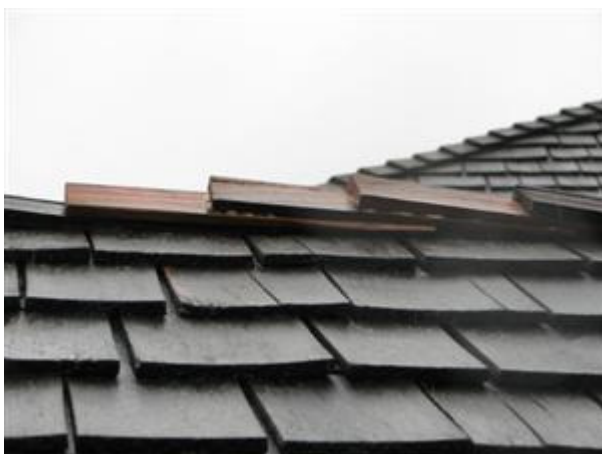
3.0 Picture 1

Some minor homeowner repairs noted (as evidenced by the extruding foam used to "stick" the shingles down). I recommend keeping an eye on these shingles to ensure they do not displace.

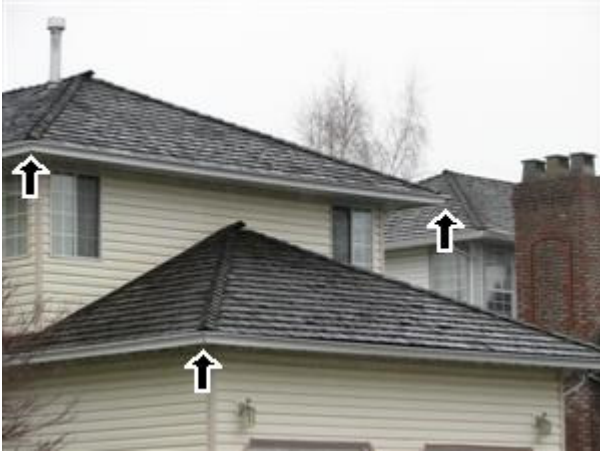
3.4 Picture 1

3.4 The gutters appear intact and in fair condition, consistent with the age of the home. Some minor leaking at the seams (where the gutters join together) was noted. These need to be re-sealed with a high-quality silicone caulking designed for this purpose. As a homeowner maintenance project I recommend a regular semi-annual cleaning and inspection of the gutters.

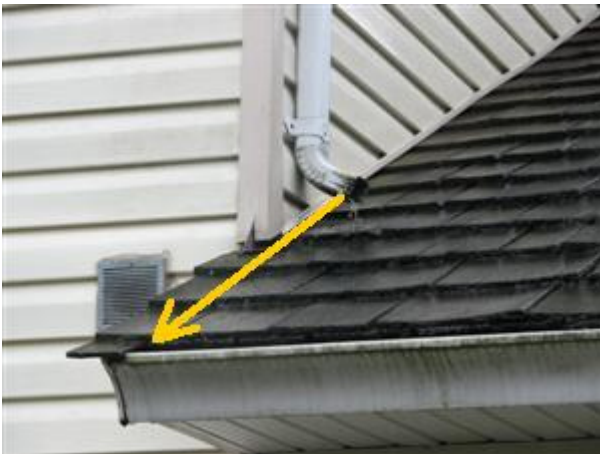
3.4 Picture 2

The collected volume of water being directly concentrated to a spill-point on the surface of the roof shortens the design life of the roof surface. I recommend extending the downspout to channel the water directly into the gutter below. This is an inexpensive upgrade that can prolong the life of your roof.

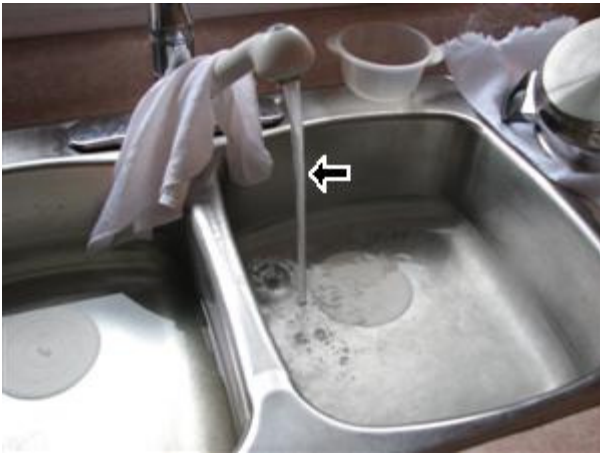
4.0 Picture 1

4.0 Water temperature was recorded at 121.6 degrees Fahrenheit. Temperatures are typically set between 110 - 120 degrees F to reduce the risk of personal injury from scalding, and to provide acceptable levels of comfort; adjust as desired. This becomes particularly important if there are small children and/or elderly in the home. No issues noted. Fixtures worked well and drainage was satisfactory. While not a defect, functional pressure seemed a little low. Homeowner can adjust to increase pressure if desired.

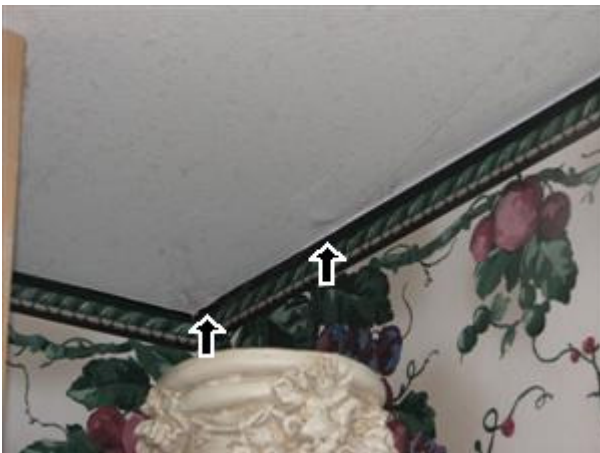
4.3 Picture 1

4.3 Some minor nail-pop noted... common with no need for concern. Cosmetic. Homeowner can repair as desired.

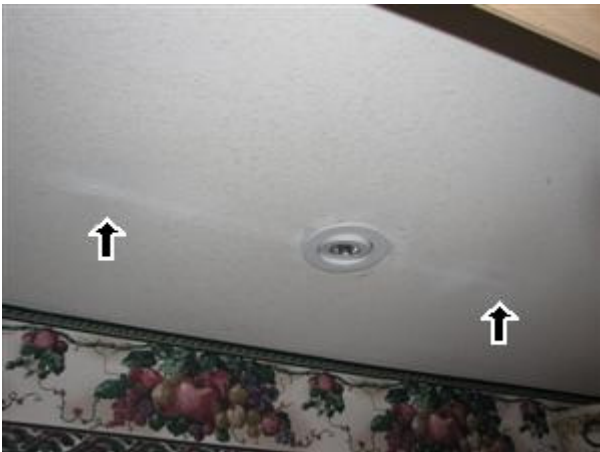
4.3 Picture 2

Previous renovation has left some minor cosmetic indications. Homeowner can repair as desired.

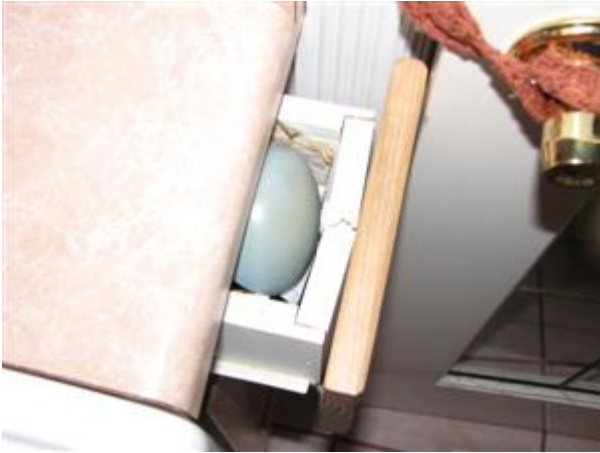
4.4 Picture 1

4.4 One hidden defect noted. Over-all the cabinets are in fair condition relative to the age of the home.

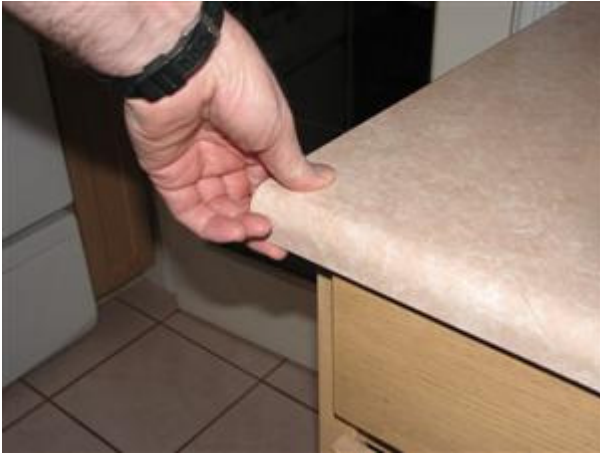
4.5 Picture 1

4.5 No issues noted. Counters are in fair condition relative to the age of the home, with small indications of wear. One corner lifting slightly. Homeowner can repair as desired.

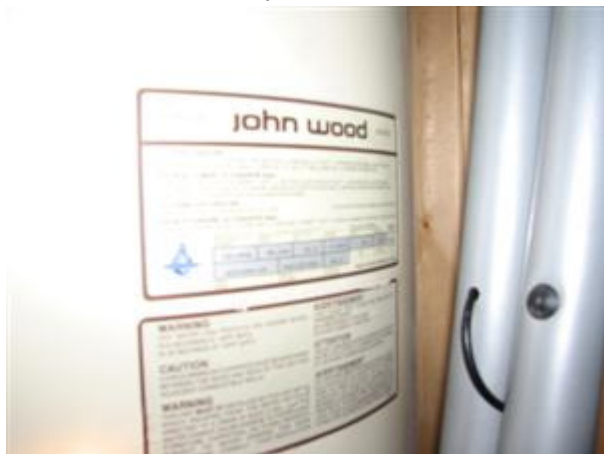
5.0 Picture 1

5.0 Original water heater, in fair condition relative to the age of the home. As tanks fail from the inside-out, it is not possible to estimate remaining life.

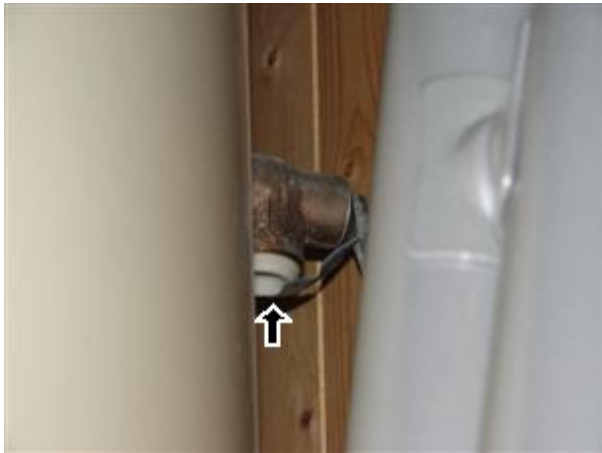
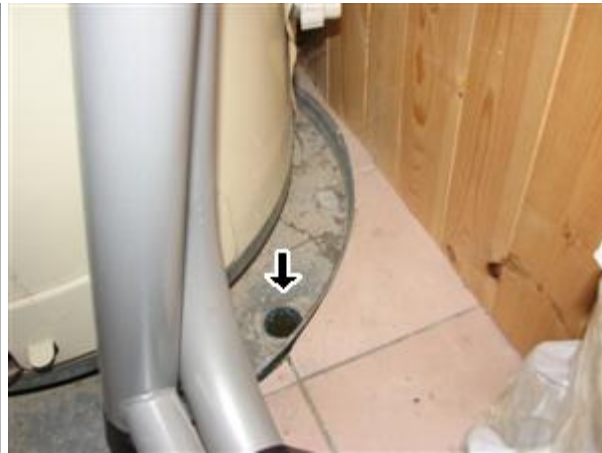
A TPRV (temperature, pressure, relief valve) is designed to safely discharge the super-heated water in the event of a water heater boil-over, protecting the floor and anything on it from water. In this case, there is a TPRV installed, however there is no discharge line directing the water to the floor pan. I recommend a licenced plumber install a discharge line.

5.3 A TPRV (temperature, pressure, relief valve) is designed to safely discharge the super-heated water in the event of a water heater boil-over, protecting the floor and anything on it from water. In this case, there is a TPRV installed, however there is no discharge line directing the water to the floor pan. I recommend a licenced plumber install a discharge line.

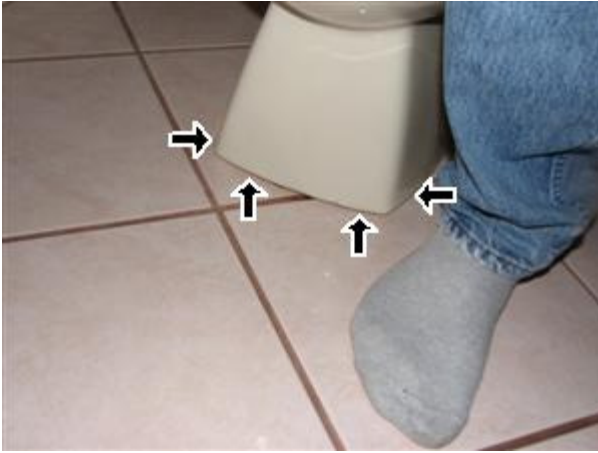
6.1.A Picture 1

Water/leaking is evident at the base of the toilet. The toilet is loose at floor at the bath. Repairs may involve re-setting the toilet on a new wax seal. I recommend a qualified licensed plumber repair or correct as needed.

Floor covering prevents absolute determination of floor substrate condition.

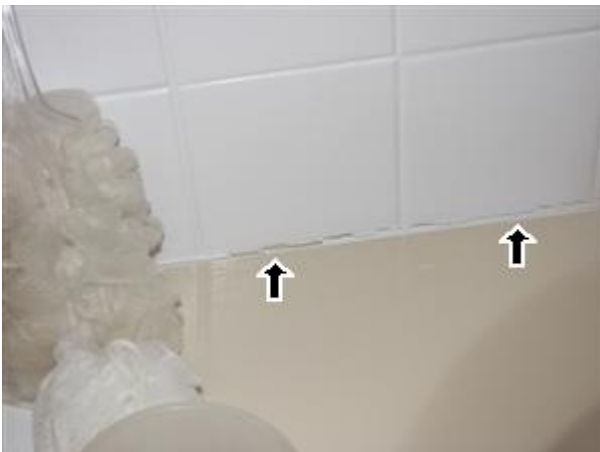
6.2.B Picture 1

6.2.B The tub is a soaker style with a tiled backsplash. Cracks in the grout were noted. As tiles will leak over time, I recommend that the entire enclosure be grouted and sealed, and that this become a regular maintenance item.

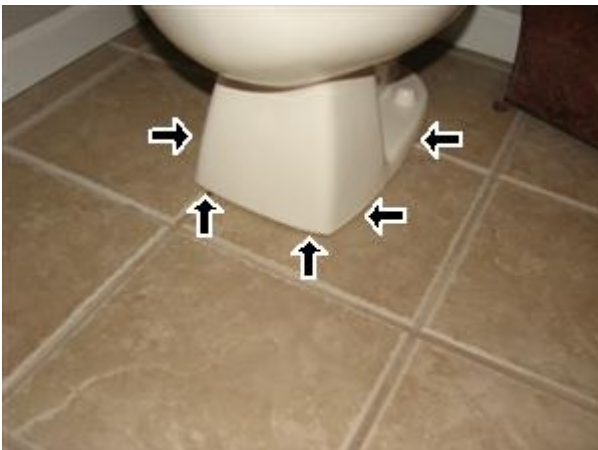
6.1.C Picture 1

6.1.C No issues noted, however for sanitary reasons I recommend caulking around the base and sides of the toilet, leaving a 6" gap along the back.

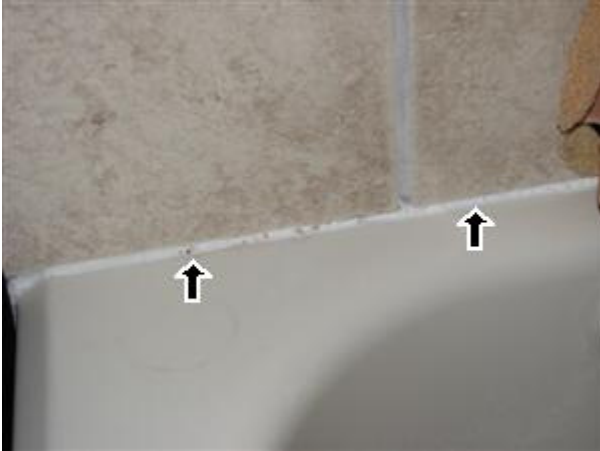
6.2.C Picture 1

6.2.C The tub has a tiled backsplash. Mildew was noted. This is indicative of high-humidity. As tiles will leak over time, I recommend that the entire enclosure be grouted and sealed, and that this become a regular maintenance item.

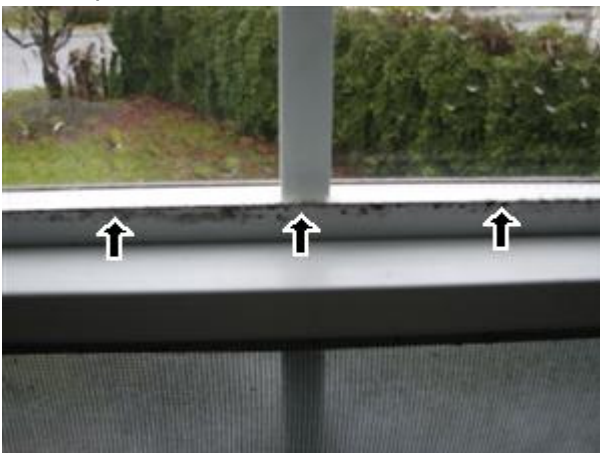
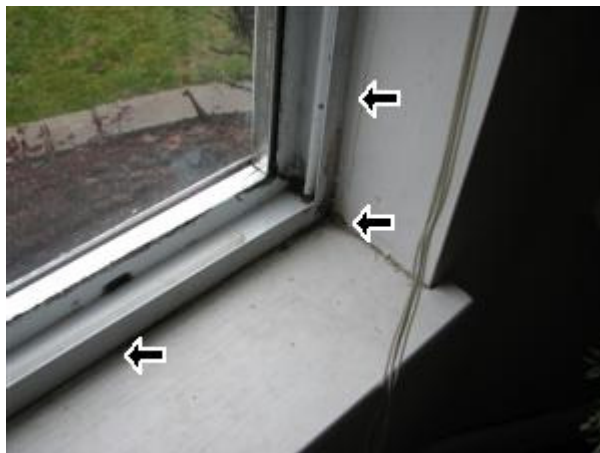
Ventilation is provided by a window only. As there is evidence of excess humidity not only in the bathroom but throughout the upstairs, I recommend that an exhaust fan be installed on a timer switch enabling it to run-on after having a bath or shower. A licenced electrician should perform the conversion.

6.9.C Ventilation is provided by a window only. As there is evidence of excess humidity not only in the bathroom but throughout the upstairs, I recommend that an exhaust fan be installed on a timer switch enabling it to run-on after having a bath or shower. A licenced electrician should perform the conversion.

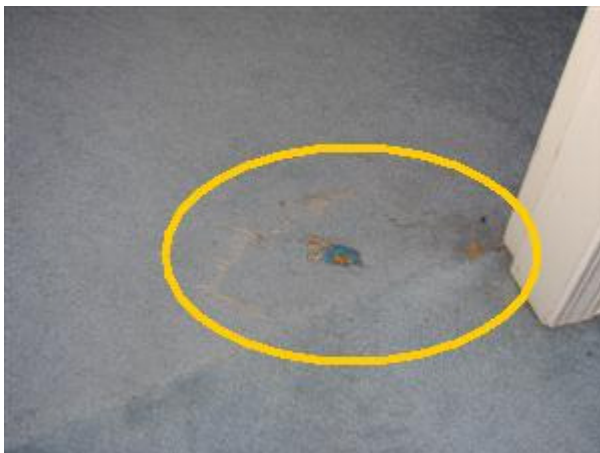
7.0 Picture 1

7.0 Aside from one damaged area in the master bedroom, no serious issues noted. Flooring appears to be in satisfactory condition consistent with the age of the home. No deflection noted, however condition of the substrate was not able to be determined.

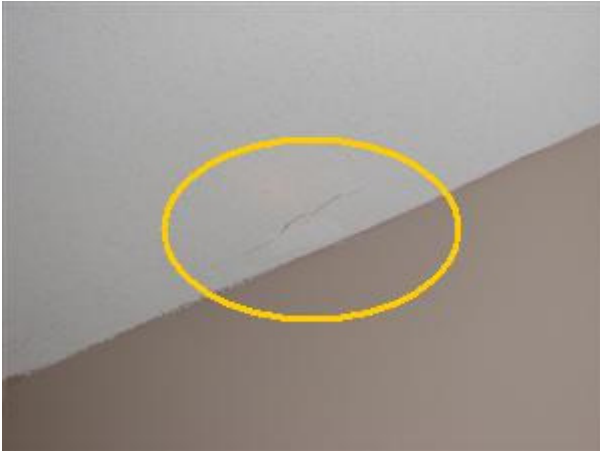
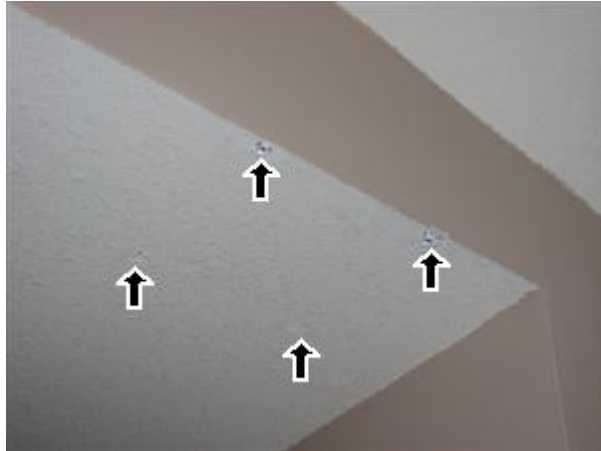
Indications of something previously hanging/installed from the ceiling in the living room/dining room was evident. This is not a defect, but a cosmetic blemish. Homeowner can repair as desired.

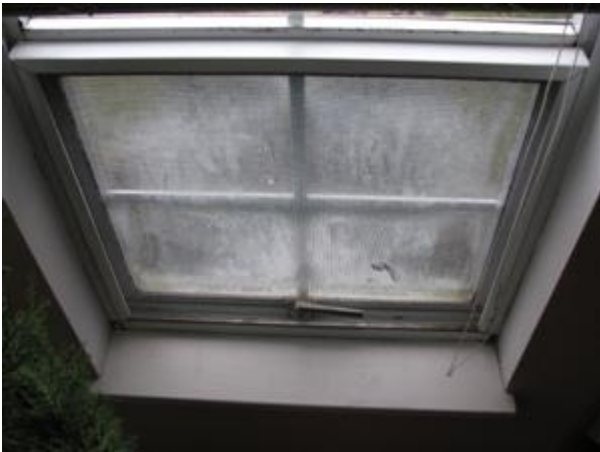
7.4 Picture 1

7.4 The condition of the windows is consistent with the age of the home. A representative sampling of the windows revealed no operational issues, however one window (living room) has lost its "seal" between the double panes. This does not affect the R-Value.

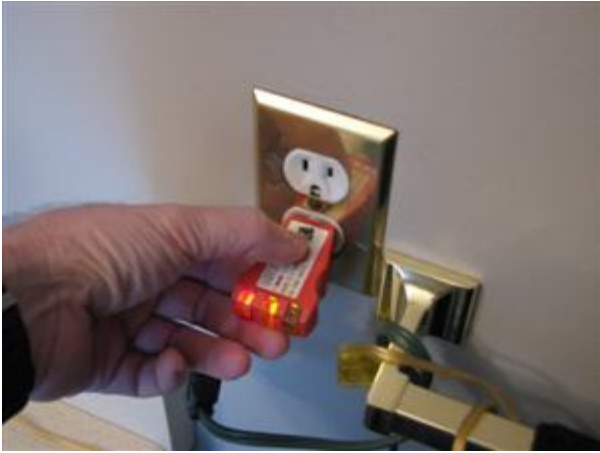
7.6 Picture 1

7.6 Testing of the receptacles revealed one operational issue... that being reversed wiring in the receptacle located in the upstairs main bathroom. As this receptacle is located in a wet area, I recommend that it be converted to a GFCI plug by a licenced electrician.

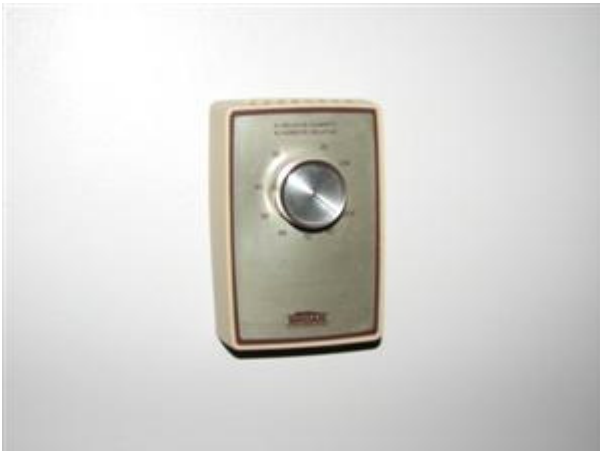
7.7 Picture 1

7.7 While a humidistat was noted as being installed, it was turned OFF at the time of inspection. Based on indications of high-humidity in the home I suspect that this has been in the off position for a long period of time. The humidistat is designed to automatically monitor and regulate moisture levels in the air. It is important - especially in newer homes which are sealed from the outside elements and much less "drafty" than older homes - that the humidistat be correctly set as to be operable (usually about 35%). If you find that the fan the humidistat is controlling is too loud for your taste, have a qualified electrician install a quieter fan, which will be much less expensive than the potential damage and health concerns that high humidity can lead to.

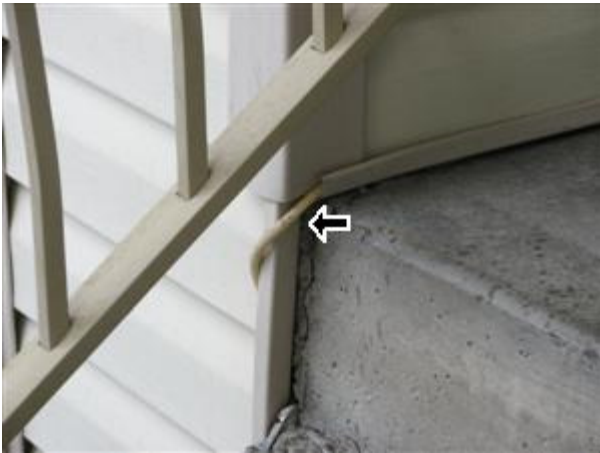
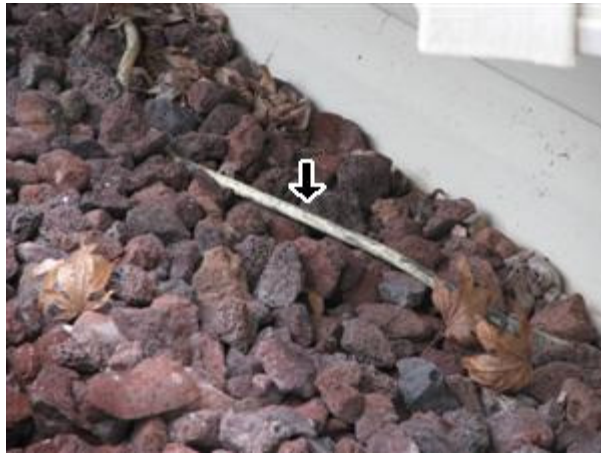
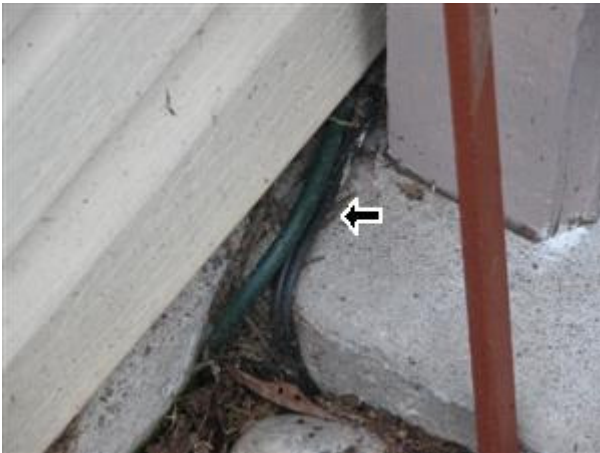
The use of extension cords for permanent wiring applications is dangerous. Extension cords are not rated for burial or permanent exposure to the elements. The casing(s) will crack over time and potentially short out. I recommend that the extension cords be removed, and should the homeowner require permanent power at the same locations, that I licenced electrical contractor install a safe and properly rated exterior source of power.

- 8.0** No issues noted. Underground service not visible.
- 8.1** Ground wire was present.
- 8.2** No issues noted with the electrical panel; professionally installed.
- 8.3** The distribution panel was located in the garage.
- 8.4** The use of extension cords for permanent wiring applications is dangerous. Extension cords are not rated for burial or permanent exposure to the elements. The casing(s) will crack over time and potentially short out. I recommend that the extension cords be removed, and should the homeowner require permanent power at the same locations, that I licenced electrical contractor install a safe and properly rated exterior source of power.

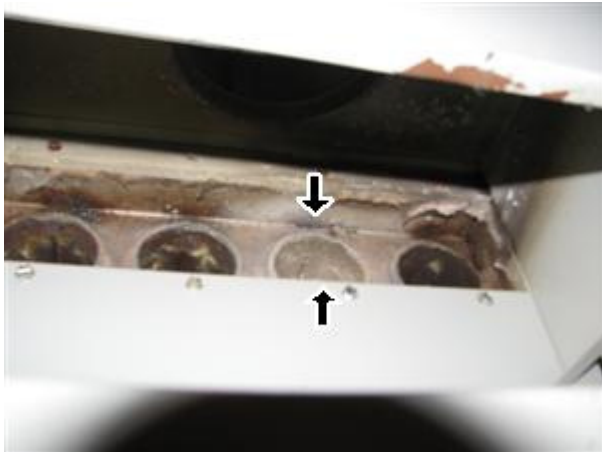
10.0 Picture 1

A likely scenario (although not confirmed until further evaluation is performed by a licenced HVAC Tech) is that the heat exchanger could be cracked. If this is the case, there is the dangerous possibility of the heat exchanger inter-mixing exhaust gases with the forced air which is being sent throughout the home.

As I could find no service maintenance record, I recommend that a Licenced HVAC Technician attend for further evaluation, and begin conducting annual service.

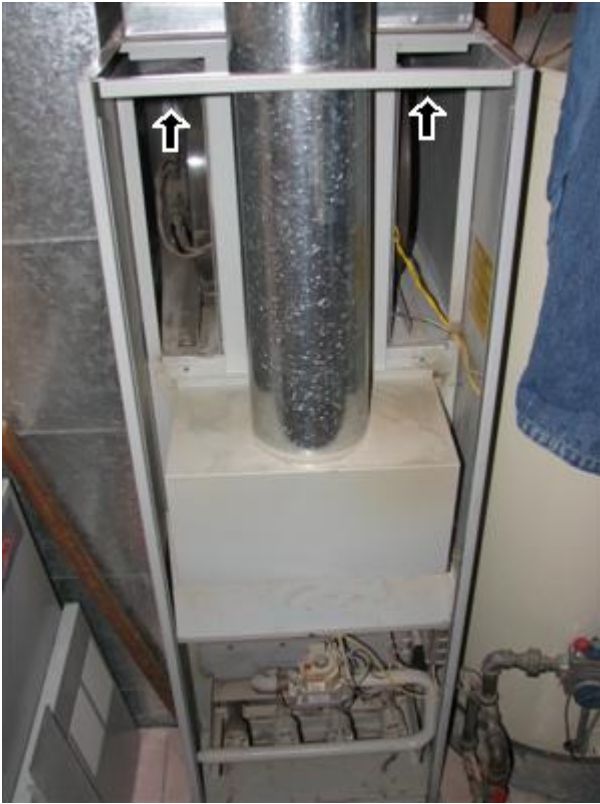
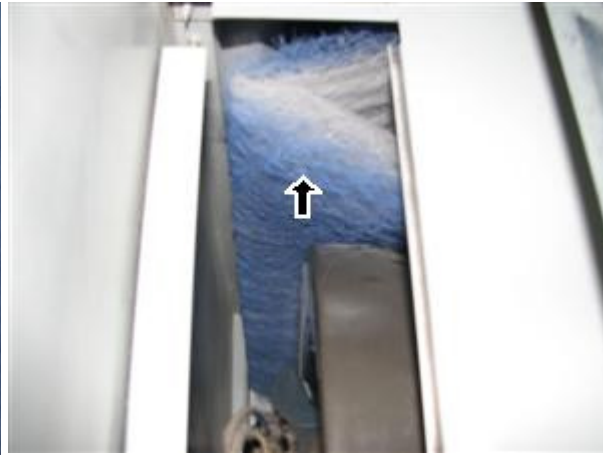
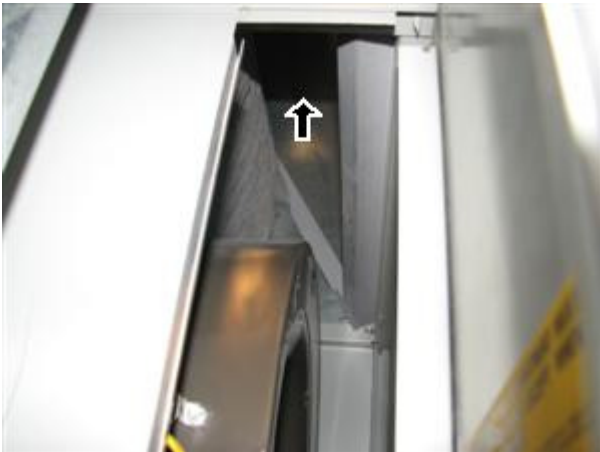
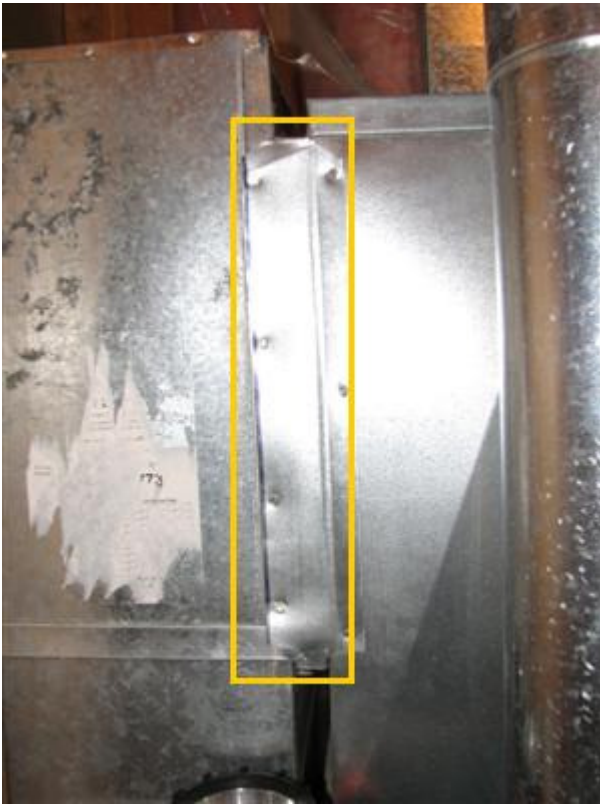
The furnace filters not correctly installed - most likely due to the inconvenient filter location/design. It is likely that this design - making the filter(s) difficult to change - lends to a 'longer than recommended' length of time between filter changes.

I recommend a licenced HVAC Technician begin annual service checks, and if possible, retrofit the filter configuration, making it more service-friendly.

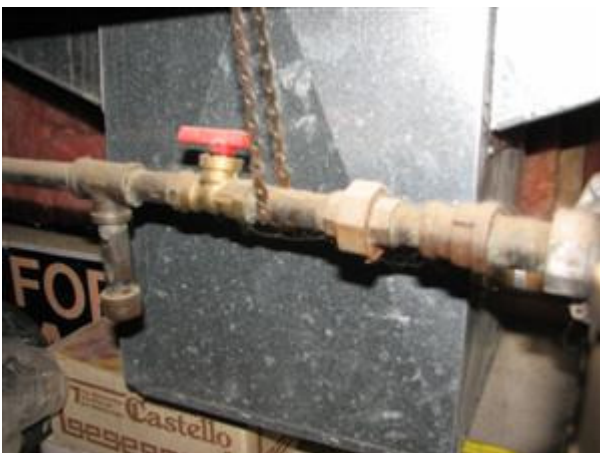
13.7 Picture 1

While no issues were noted with the crawlspce ventilation, I did note a slight smell of natural gas upon entering. I recommend a licenced HVAC Tech (or gas fitter) inspect the gas lines for slow leaks by spraying a soap & water mixture on all the joints, looking for any bubbling.

Under no circumstances should a spark or open flame be used in the crawlspace.
