Inspection Report

32215 ***** Dr
Abbotsford, BC V2T 5C7

West Coast Home Inspections Ltd.

Date: 2/19/2007	Time: 10:30 AM	Report ID: 070219
Property: 32215 ***** Dr Abbotsford, BC V2T 5C7	Customer: P ***** M *****	Real Estate Professional: Colleen Love Landmark

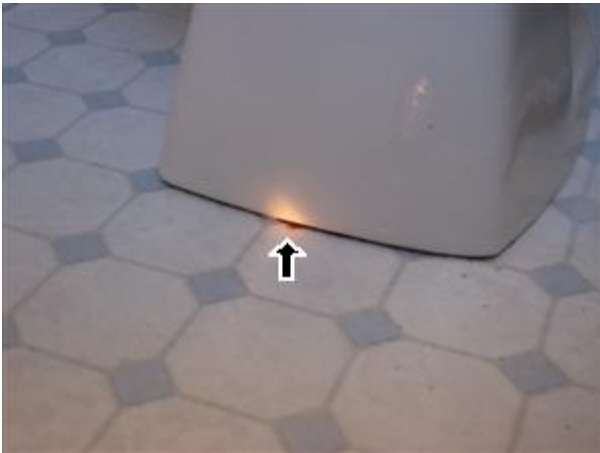
6.1.B Picture 1

6.1.B Water/leaking is evident at the base of the toilet. The toilet is loose at floor at the bath. Repairs may involve re-setting the toilet on a new wax seal. I recommend a qualified licensed plumber repair or correct as needed.

Floor covering prevents absolute determination of floor substrate condition.

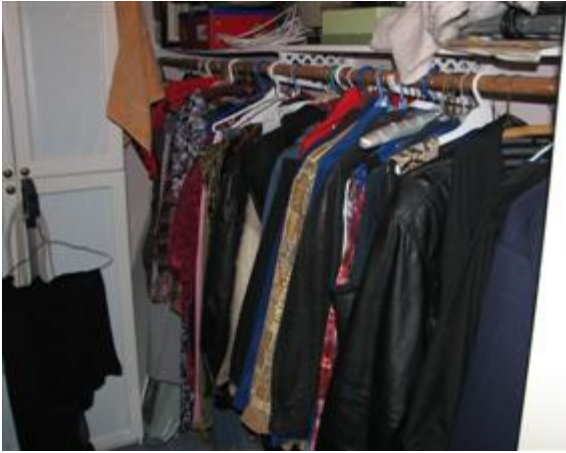
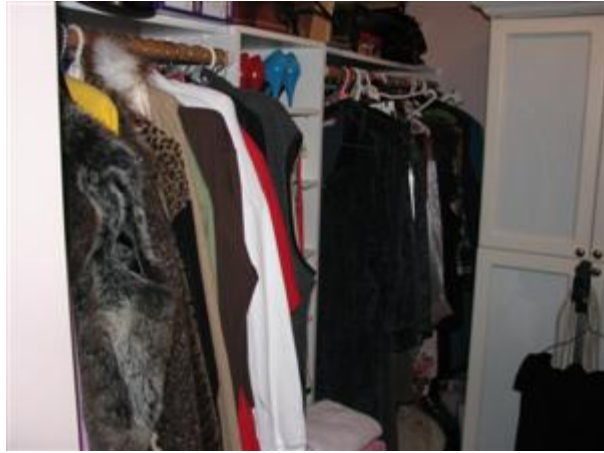
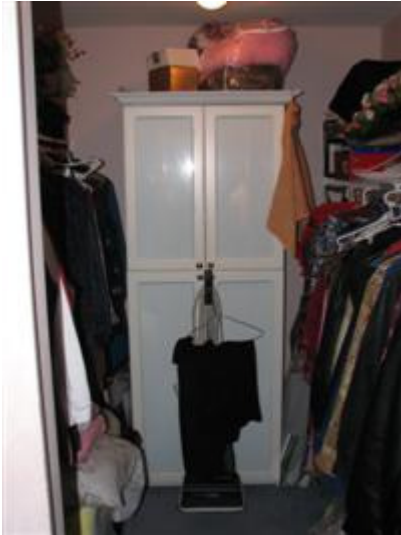
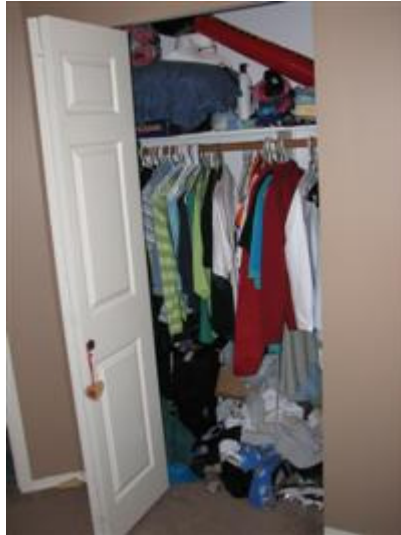
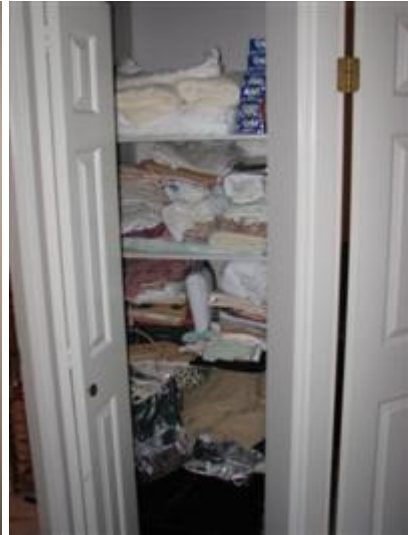
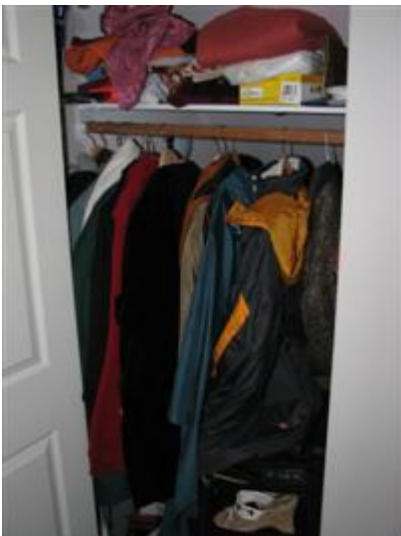
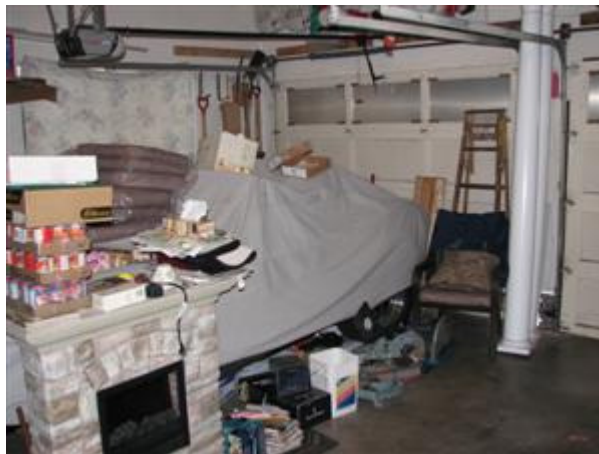
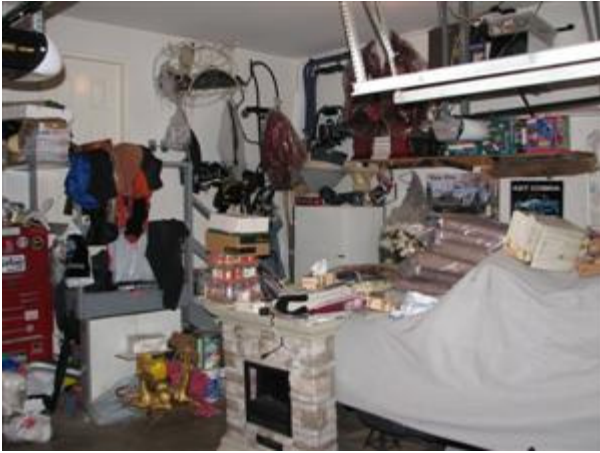
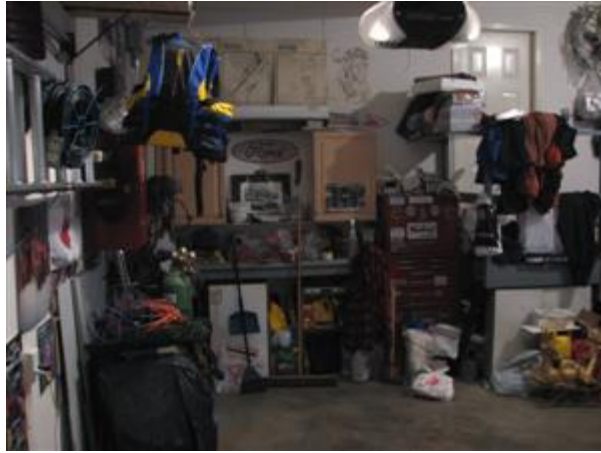
7.10 There were a number of areas (walls & floors) which I could not visually inspect due to the areas being filled to capacity.

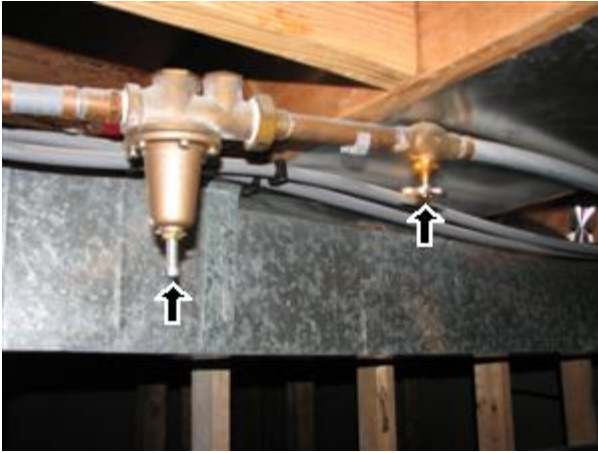
9.0 Picture 1

9.0 Main water shut-off and pressure adjustment is located in the crawlspace.

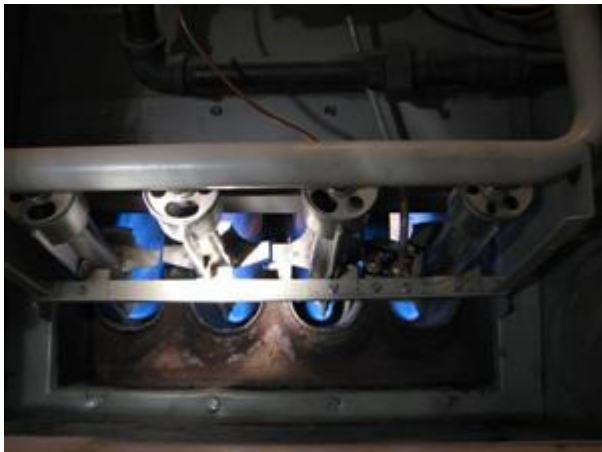
10.1 Picture 1

10.1 No issues noted when I fired the furnace and observed the burners in operation.

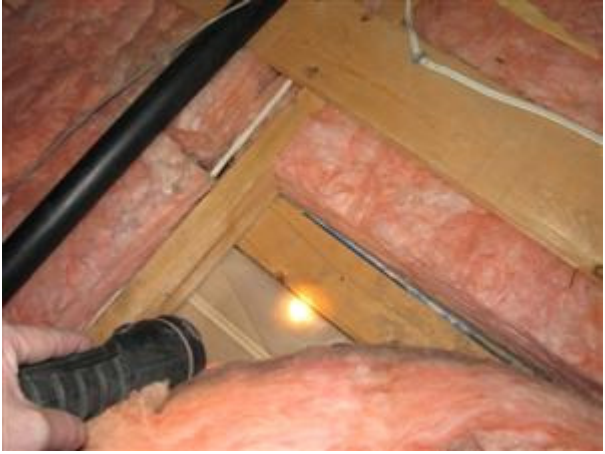
11.3 Picture 1

- 11.0** The framing appeared to be in satisfactory condition, with no un-engineered modifications.
- 11.1** The roof trusses were vertically strapped to accommodate the wood shakes/shingles. No issues noted.
- 11.2** Attic access was located in the ceiling of the walk-in closet of the master bedroom.
- 11.3** Attic insulation was present and correctly installed, however as current standards have far-exceeded the present 4" of batt insulation, I recommend installing another layer of insulation over top of the existing layer to double the insulating properties.

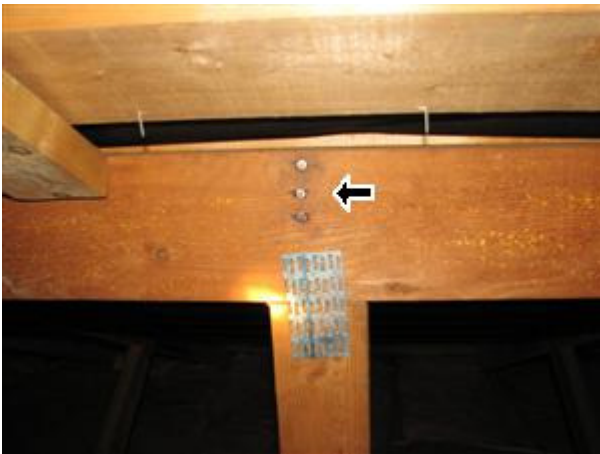
11.4 Picture 1

11.4 Baffles were present and the attic felt "fresh" upon entering. No indications of poor ventilation.

Shiny nails (not rusted) are a good sign!

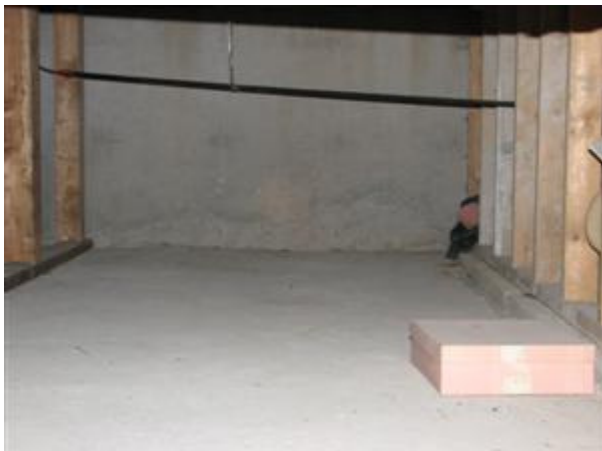
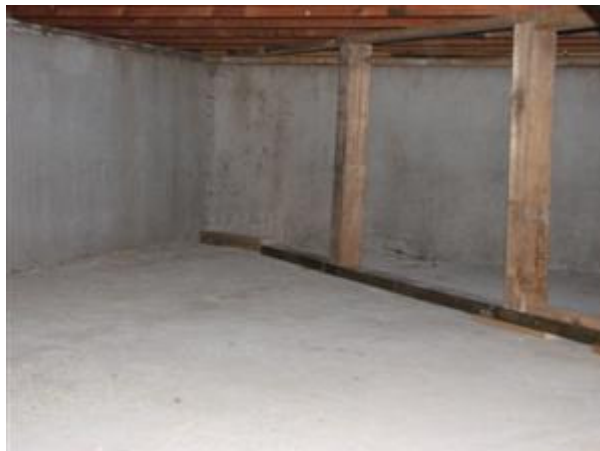
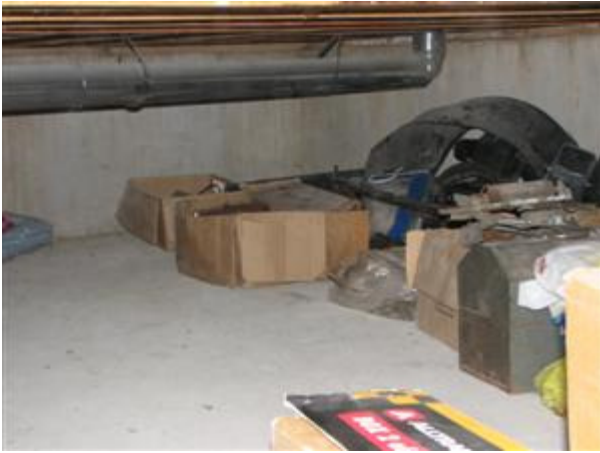
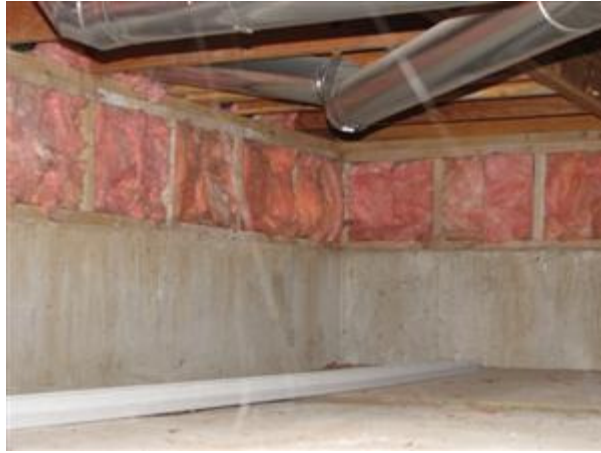
13.0 From what was visible, the foundation looked to be in satisfactory condition, with no evidence of cracking or water infiltration.
